NACA RM E56E24

PERFORMANCE OF INCONEL 739 BUCKETS IN
J33-9 TURBOJET ENGINE

By C. A. Gyorgak and J. R. Johnston

Lewis Flight Propulsion Laboratory
Cleveland, Ohio

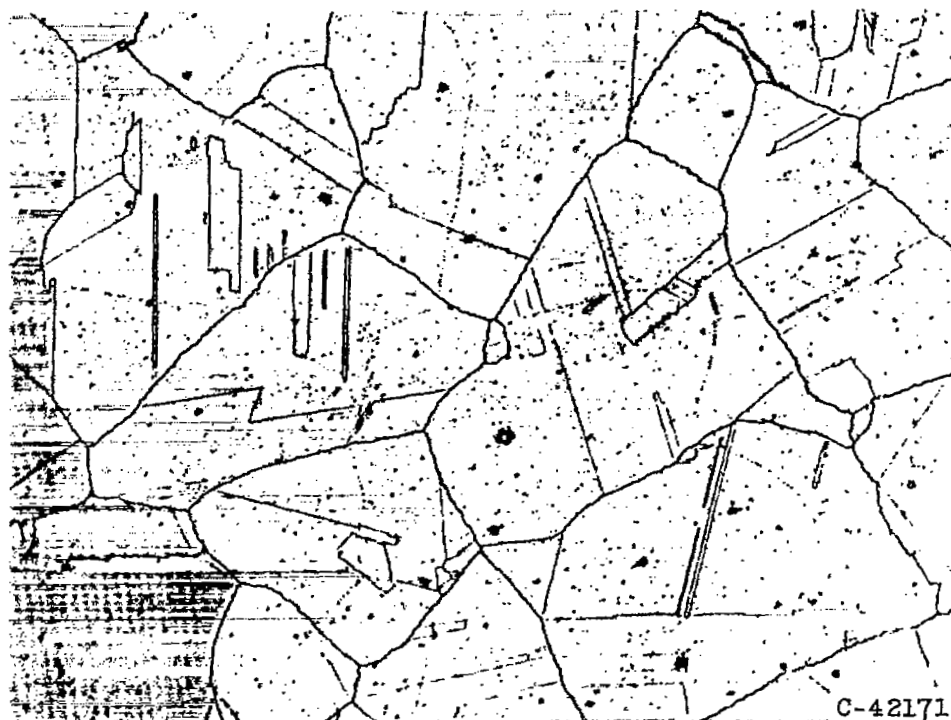
(a) As-heat-treated bucket.

Figure 7. - Typical microstructures of Inconel 739 bucket. Etchant: 20 cc glycerine, 20 cc water, 5 cc HF; electrolytic. X250.

Typical microstructures of Inconel 739 buckets are shown in figure 7. Figure 7(a) shows the microstructure of the as-heat-treated bucket and figure 7(b) shows the microstructure of a bucket operated for 300 hours at rated speed. The differences in microstructure noted in these figures are attributable to the increase in precipitation which occurred in the bucket during 300 hours of operation.
